**FINEGAN INSPECTION SERVICES, INC.**  
**76 W. FOSTER MAINEVILLE RD.**  
**MAINEVILLE, OHIO 45039**  
**683-0733-PHONE 697-0163-FAX**

Lot #47, Ohio

This is a **specialty construction report** as per the clients' request. The report is designed to discuss the conditions of the **foundation**, at the above address. The above mentioned conditions were observed on January 5, 2006.

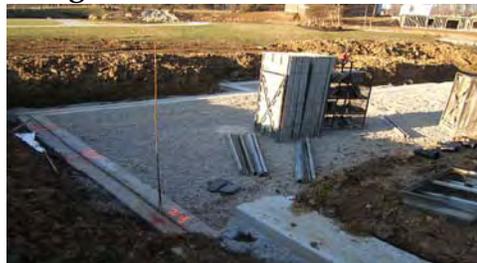
2). There was a **keyway in the footers**. This is intended to help "lock" the foundation to the footings and allow a break in the bond so that water movement is not impaired. the intersection footings would

This should insure that of the foundation and the properly seal the

footer/wall intersection.

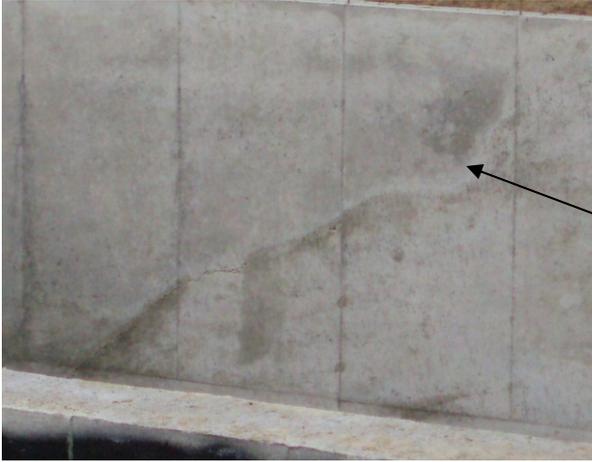
2). There was a concrete cast-in-place **foundation** installed on the site. It was noted to be plumb and appeared to be relatively square. Photo #6. With all the offsets in the foundation no calculations were attempted to determine the exact foundation conditions as in comparison to the drawings.

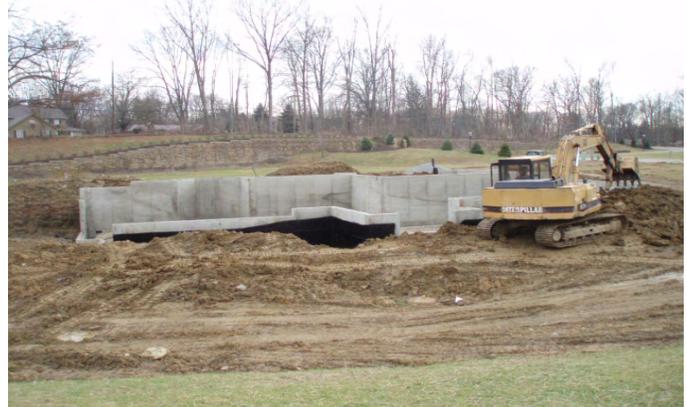
3). There were **pour lines** in the foundation, (none that would be indicative of poor quality pouring and/or concrete), but large enough to be monitored and possibly parged

over. There is no observed bowing to the foundation wall surfaces.

The only concern is that the entire foundation was poured, spray sealed and backfilled all within 72 hours. That leaves very little time for the concrete to cure. The weight of the wet clay soil against the outside of the concrete wall only could cause cracking in the foundation.

Traditionally the foundation would be backfilled **after** the concrete floor is poured and the floor is installed. In this way the foundation is properly braced off. This firm will keep a close eye on the wall system over the course of the building process.

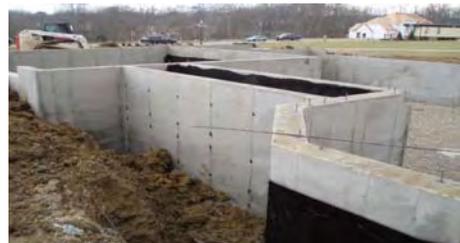
3). There was noted **spray sealant application** accomplished at the time of the inspection. The sealant is a tar-based product applied to the exterior foundation walls that are exposed to soil. The sealant, which is typical in the industry, was properly applied on all the exterior foundation wall surfaces. The sealant will not “waterproof” the foundation, but it will lower potential for leakage on the wall surfaces.

It is normal that there is no water proofing spray applied to the sub-grade front wall of the front porch. The area is filled with gravel and is not common to any living space. See photo of the spray sealant.

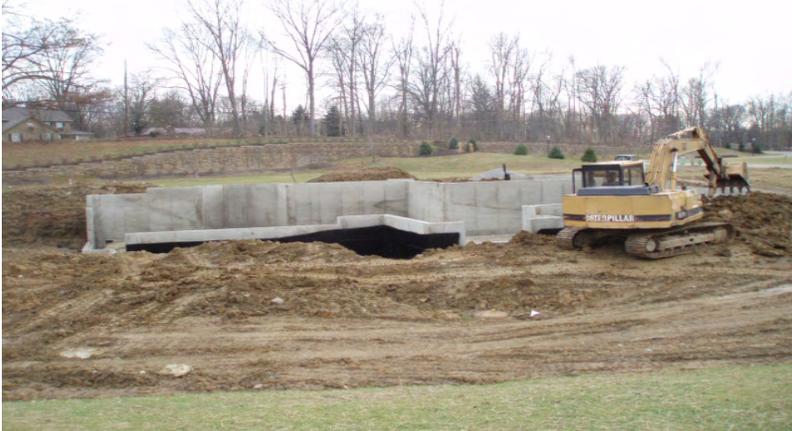
4). The **site** was noted to be without problems in terms of elevation of the foundation. There is a positive elevation of the home and all grade conditions appear to direct any future surface water away from the foundation wall surface. It was positive on all 4 sides.

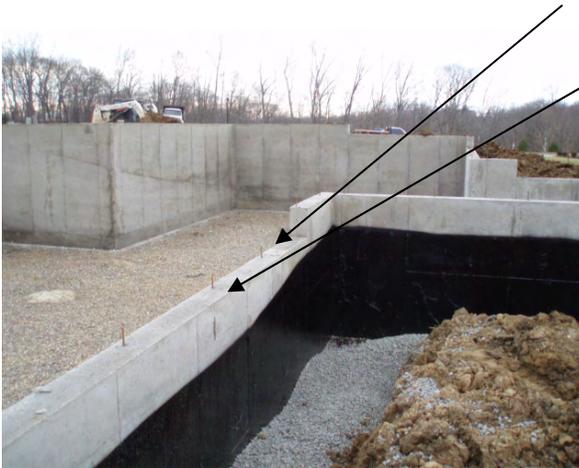
5). The foundation is set up to have **sill plate** installation with foundation bolts. This is the best way to secure the framing to the concrete surface of the foundation. As seen in photo #1, the **foundation bolts** were set up to secure the sill plate to the foundation.
