# Finegan Inspection Services Inc.

## CONFIDENTIAL INSPECTION REPORT

Sandmar, Cincinnati, Ohio 45242

3/13/2006 1:30 pm to 4:30 pm

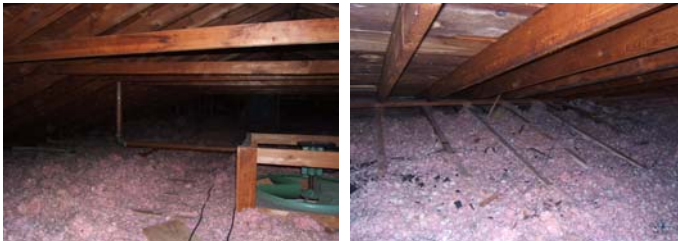
The low levels of insulation were noted in the attic area. It appears to be partly caused by past access by vermin. The addition of 8" of insulation to the existing insulation is needed.

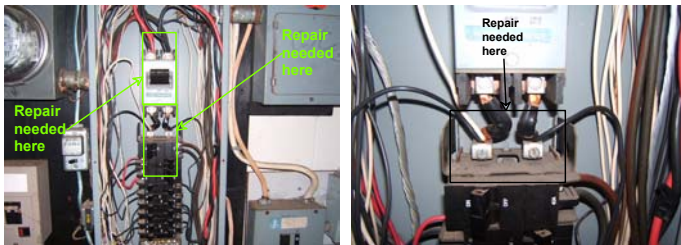
There were wires noted to be "tapped" off of the main feed wire securing lugs into the main electric panel. These were connected to the lugs prior to the main fuses. This is a potentially dangerous wiring practice and is not in conformance with any local or national electric code requirements. The review of this condition and necessary modification are needed. Only a professional electrician should make the necessary repairs.
